DYNAMIC SCIENCE, INC.
In-Depth Accident Investigation

Contract DTNH22-94-A-07049
Case DSI-96-SB-02

TECHNICAL SUMMARY

This case was selected due to a nylon coat drawstring becoming entrapped in a school bus hand rail and the wearer being dragged and run over by the school bus.

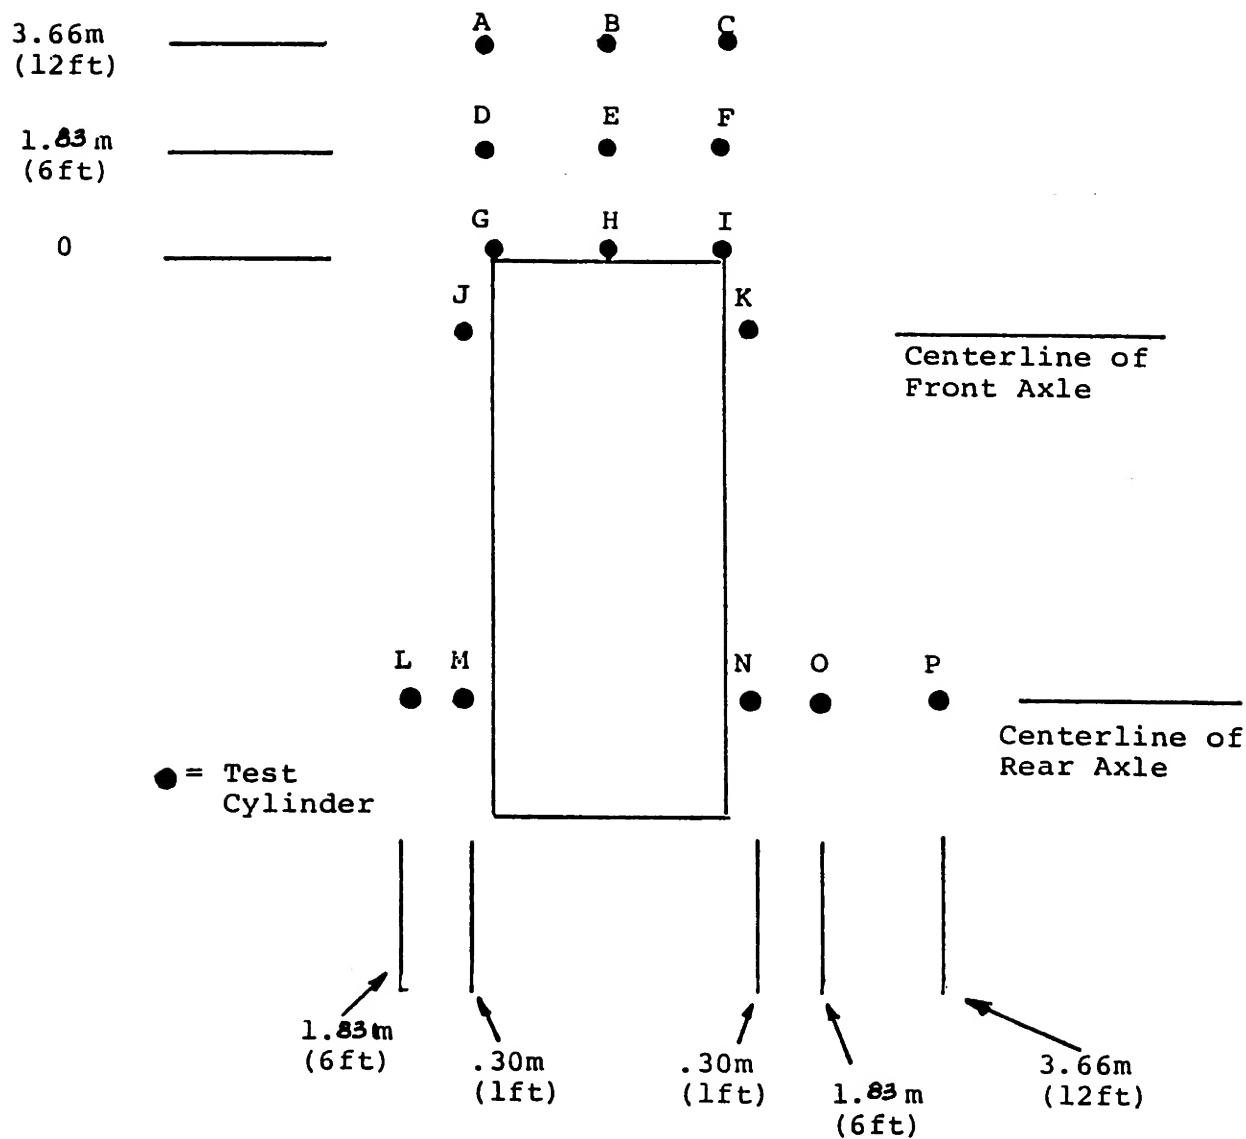
Figure 1

This school bus field-of-view test was conducted by Dynamic Science, Inc. six days post event using orange colored test cylinders measuring 30.5 cm (12 in) in height and 30.5 cm (12 in) in diameter. The test cylinders were positioned as depicted in Figure 1.

LOCATION OF TEST CYLINDERS FOR SCHOOL BUS FIELD-OF-VIEW TEST

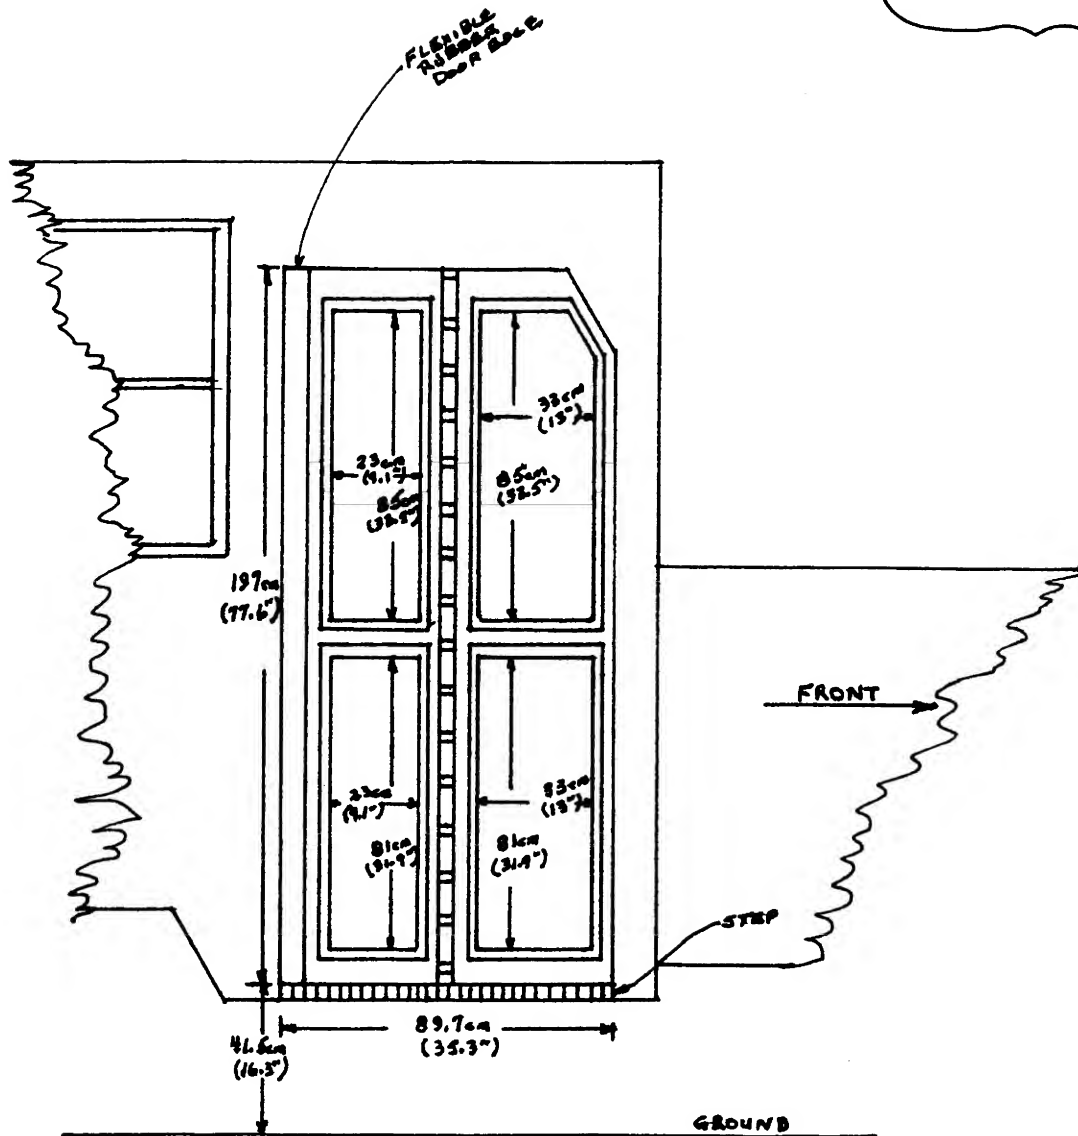
Figure 2

1. Entrance Door/Stepwell: The entry door of the 66 passenger conventional school bus is a two panel, inward opening bi-fold door that measures 89.7 cm (35.3 in) in width. The three step stepwell width measures 55 cm (21.7 in) at bus floor, 65.5 cm (25.8 in) at the front of step 2 and 89.7 cm (35.3 in) at the front of the bottom step. As the bi-fold door opens inward into the stepwell, the effective usable space on the bottom step and step 2 is reduced to 60 cm (23.6 in). Because of the narrowness, clothes and other loose items are easily caught, entangled or wedged into the projecting handrail especially when passengers are wearing bulky, cold weather clothing (see Figures 2 and 3).

BUS DOOR, CLOSED - EXTERIOR VIEW

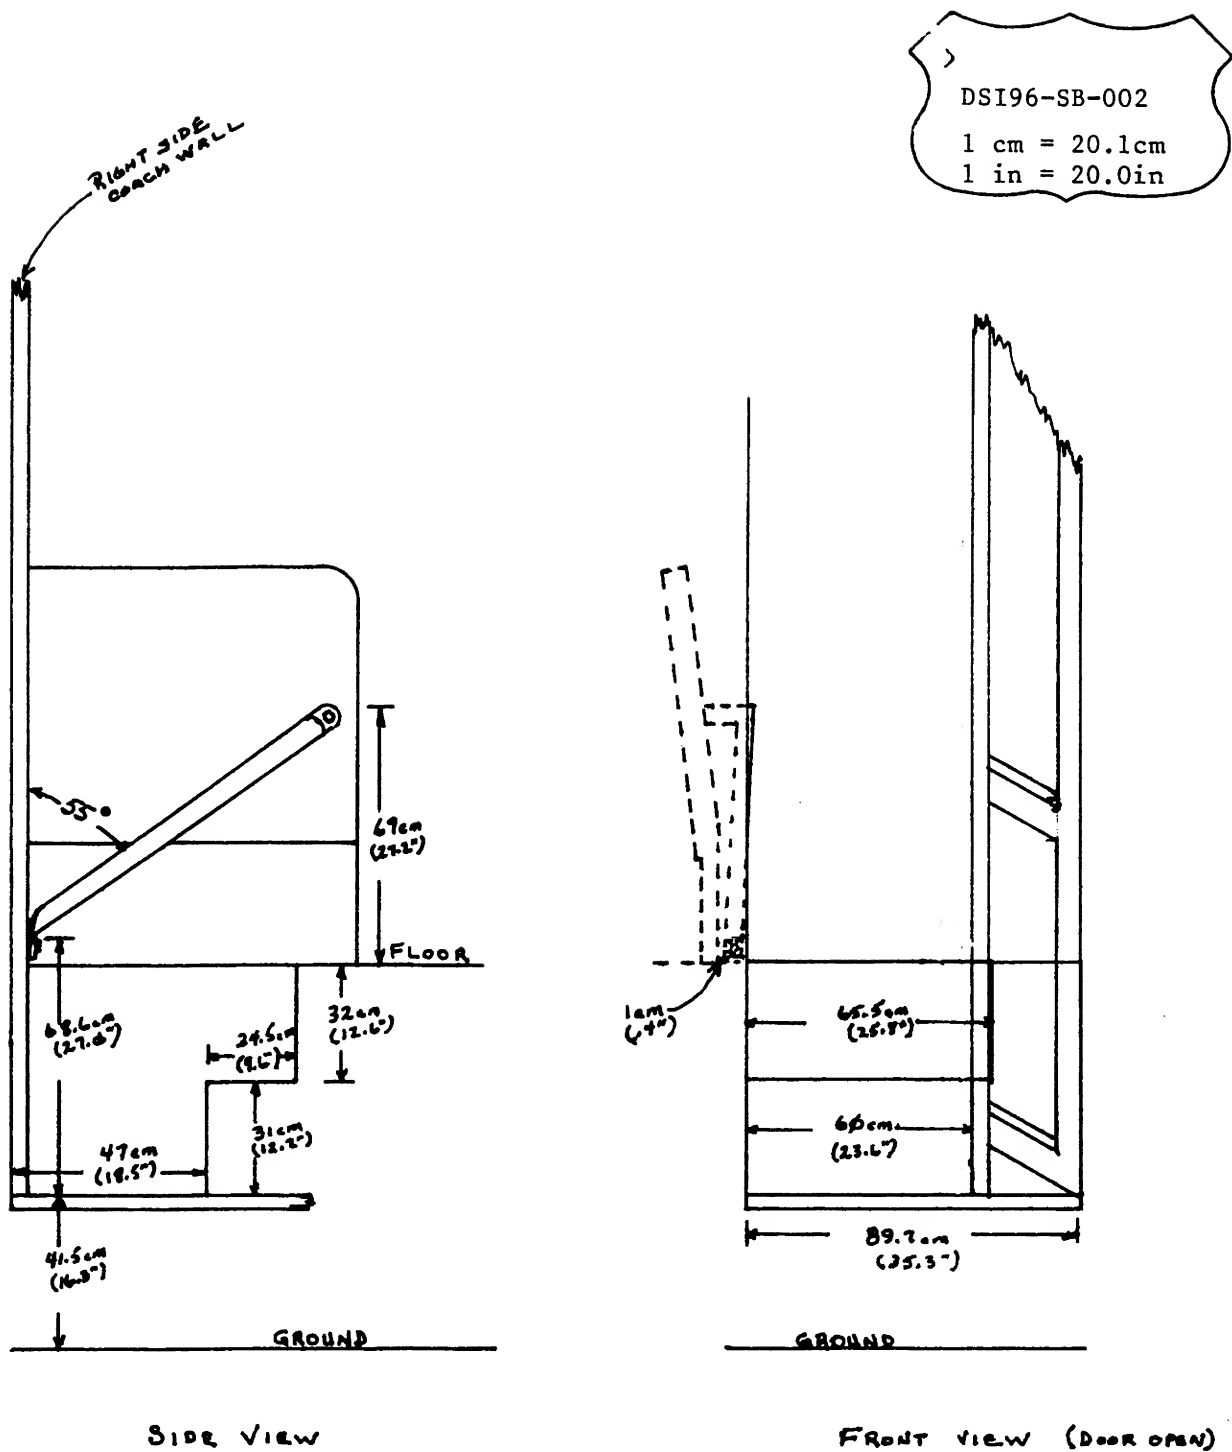
Figure 3

The 1992 66 passenger conventional school bus has a two step entry/exit stepwell with a two panel, inward opening bi-fold door. With the doors closed the bottom step measures 89.7 cm (35.3 in) in width, but with the doors open, the effective usable width is 60 cm (23.6 in). The stepwell is also equipped with a 4 cm (1.6 in) diameter tubular stainless steel grab rail mounted on the right side of the well as one exits the bus. The lower end of the grab rail is attached to the entrance door body pillar of the bus at a 55° angle and 1 cm. (0.4 in.) from the modesty panel (see figure 3).

STEP WELL
